**FIRE PERFORMANCE EVALUATION OF M N CHAI CORPORATION CO., LTD.'S, AATIS/FR 4-MM THICK ALUMINUM CLAD PANEL, TESTED IN ACCORDANCE WITH UBC 26-9, METHOD OF TEST FOR THE EVALUATION OF FLAMMABILITY CHARACTERISTICS OF EXTERIOR, NONLOAD-BEARING WALL ASSEMBLIES CONTAINING COMBUSTIBLE COMPONENTS USING THE INTERMEDIATE-SCALE, MULTISTORY TEST APPARATUS, 1997 EDITION**

**FINAL REPORT**  
**Consisting of 35 Pages**

**SwRI® Project No. 01.15677.01.002**  
**Test Date: August 26, 2010**  
**Report Date: September 23, 2010**

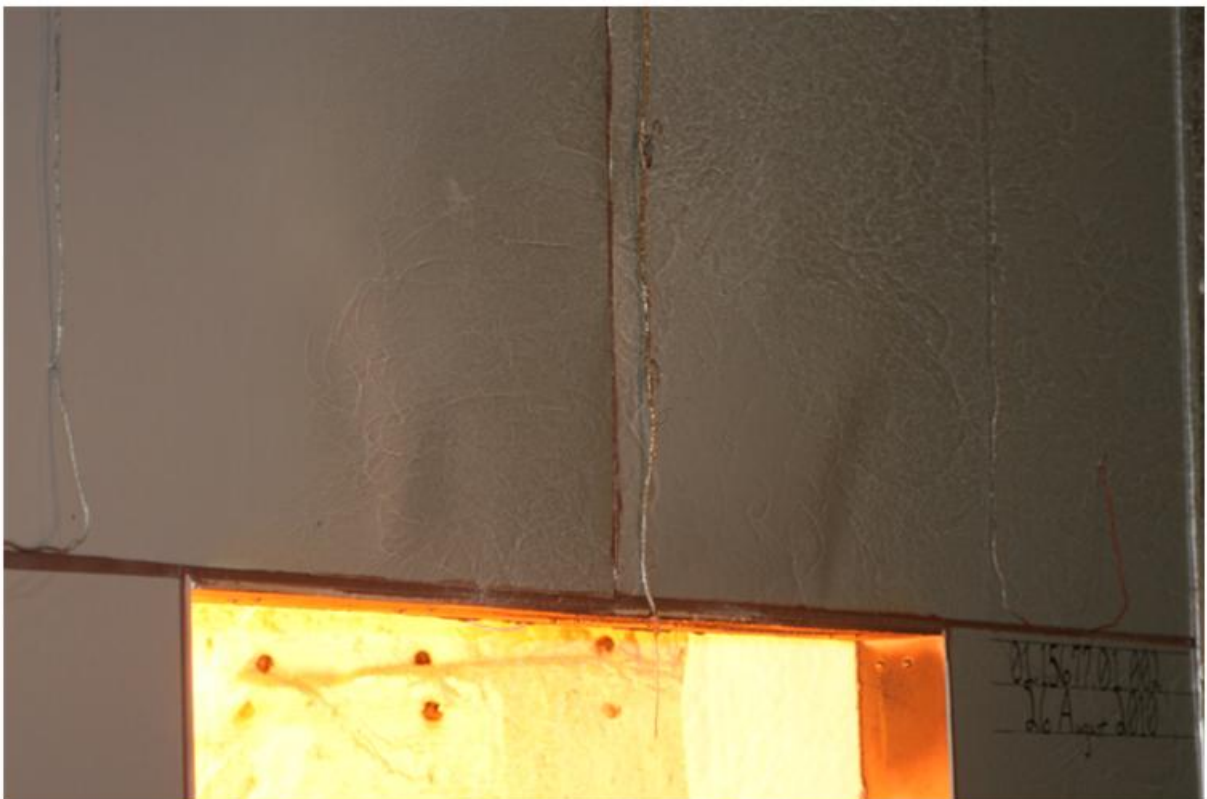
**Figure B-2. Initial Deflection above Window.**

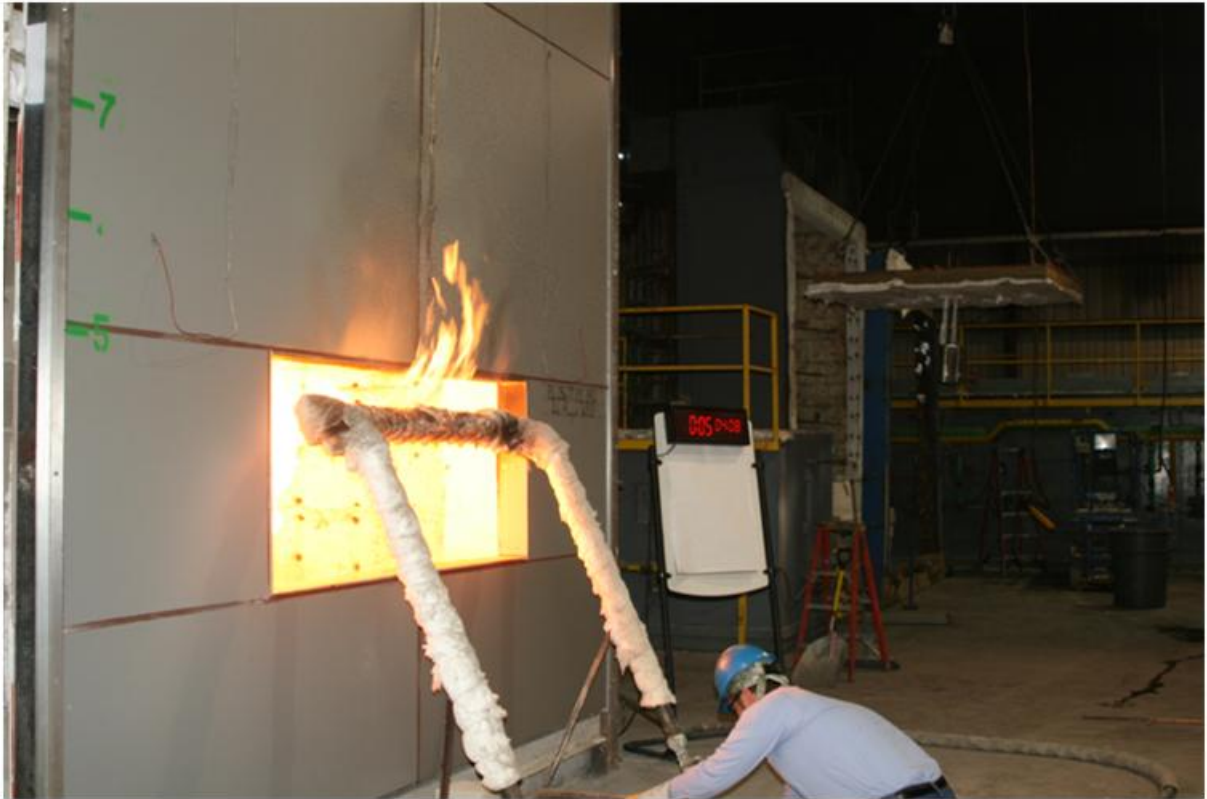
**Figure B-3. Application of Window Burner.**

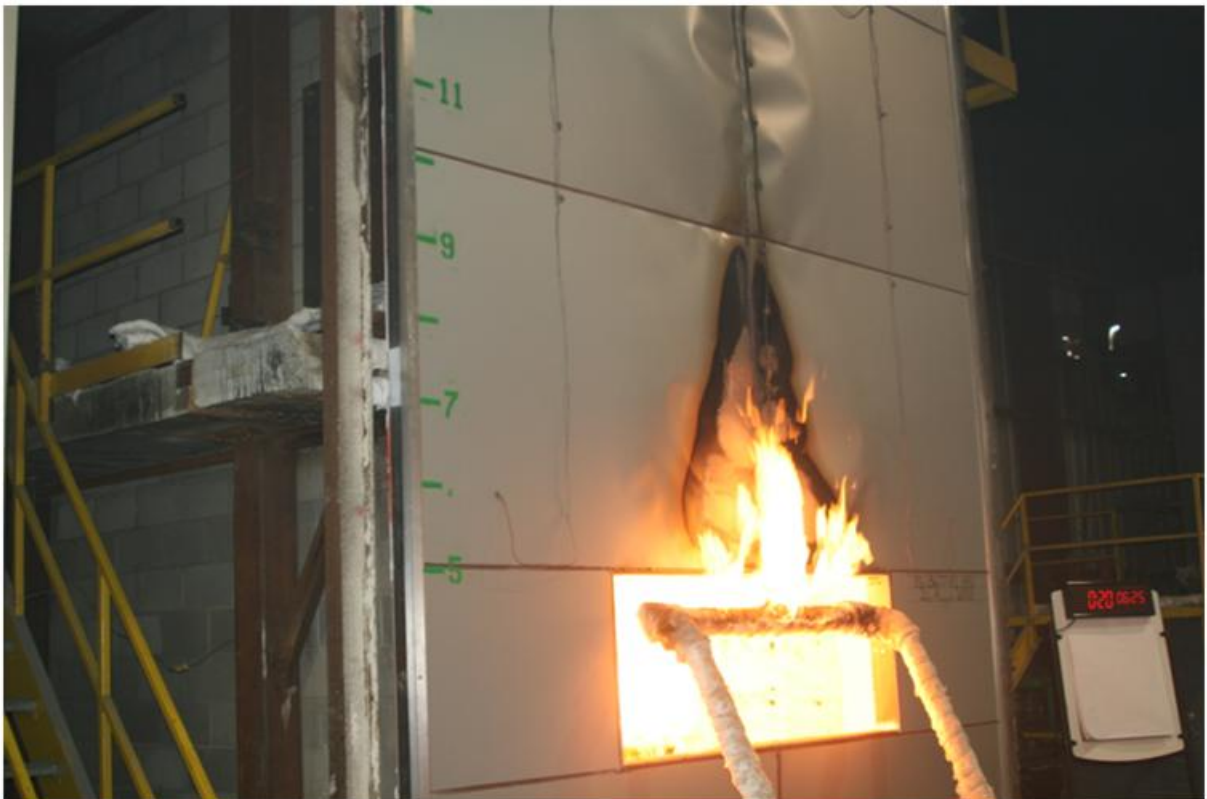
**Figure B-4. 20 min into Test.**

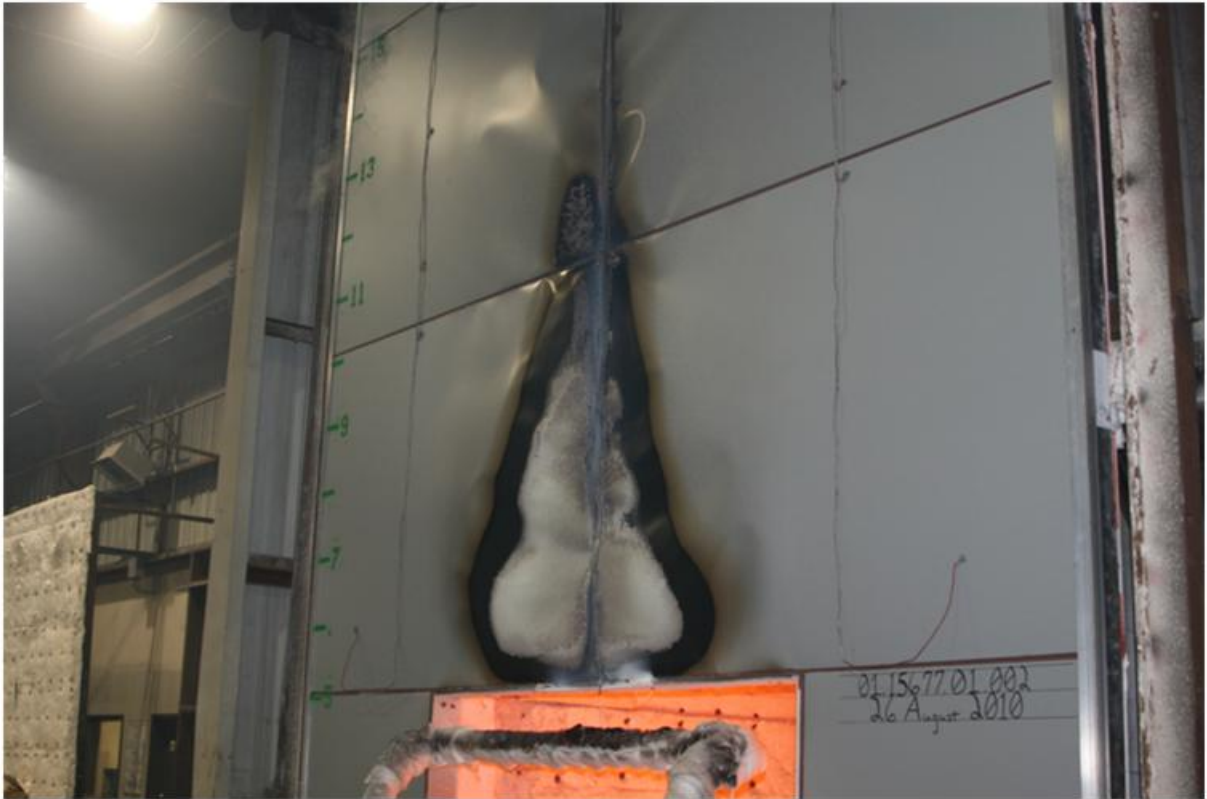
**Figure B-5. End of Test.**

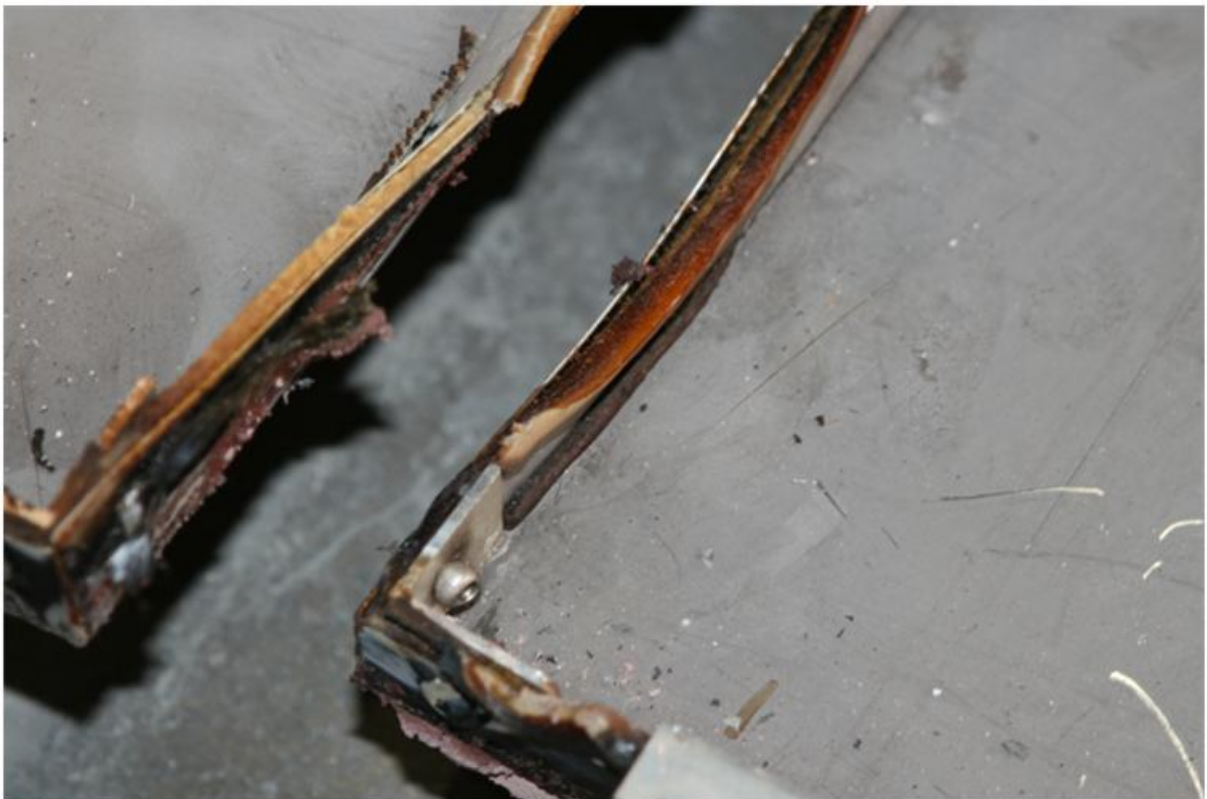
**Figure B-6. Backside of Panel Following the Test.**

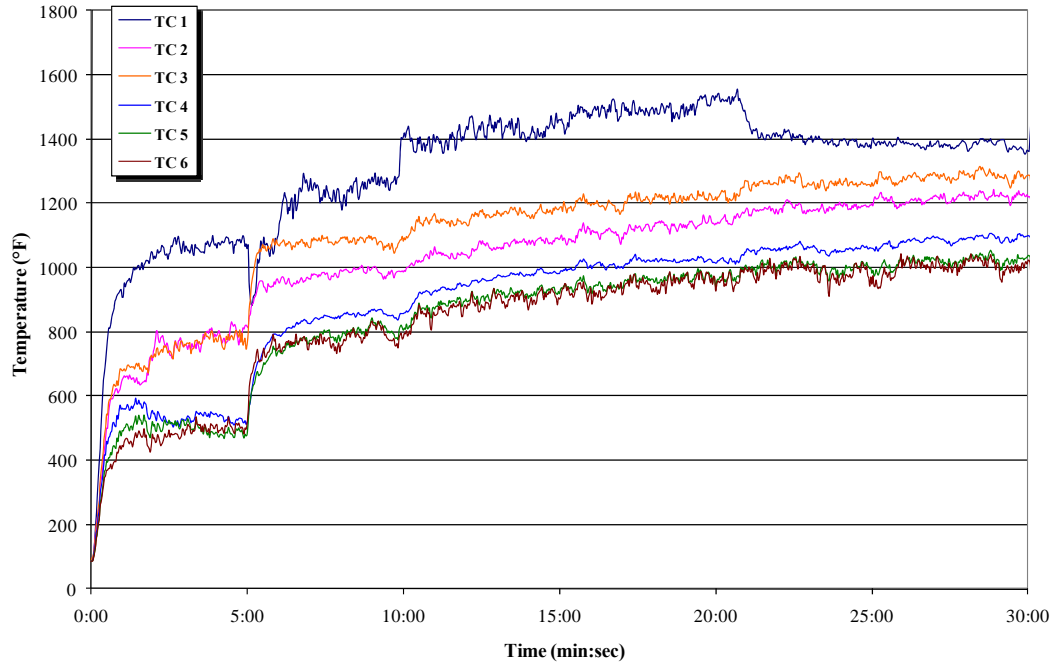
Figure C-1. Exterior Wall Temperatures (TCs 1-6).

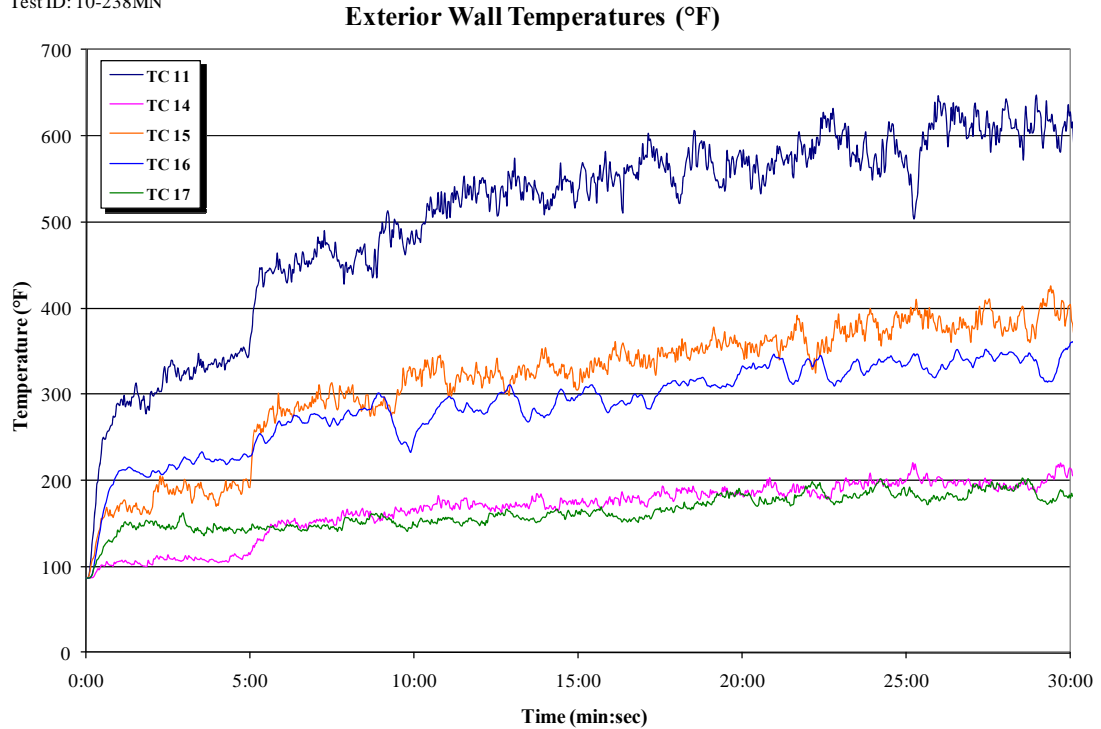
**Figure C-3. Exterior Wall Temperatures (TCs 11, and 14-17).**

1. TCs 11 and 14–17 did not exceed 1000 °F at any time during the test.
2. Flames emitting from the surface of the exterior face did not reach a vertical elevation of 10 ft above the top of the window opening at any time during the test.
3. Flames emitting from the surface of the exterior face did not reach a lateral distance of 5 ft from the vertical centerline of the window opening any time during the test.

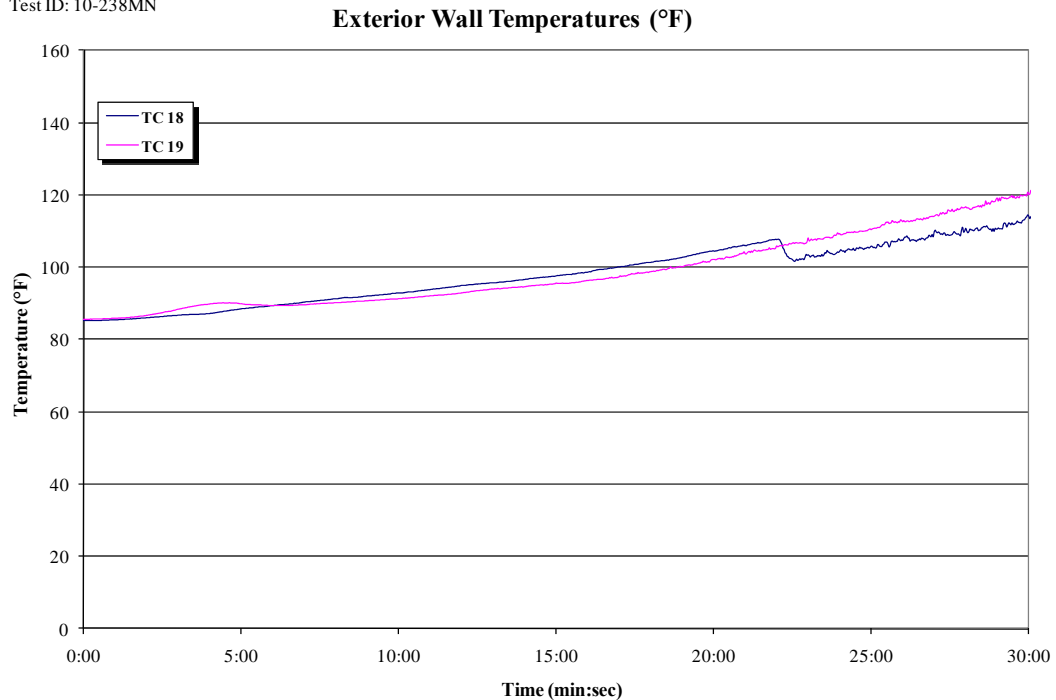
**Figure C-4. Exterior Wall Temperatures (TCs 18 and 19).**

1. Flames did not occur over the surface of the exterior face beyond the concrete block walls or beyond the intersection of the test wall assembly, and the concrete block fixture walls.
2. TCs 18 and 19 did not exceed 750 °F above their temperature as measured at the start of the test at any time during the test.
